# Manhole Inspection Summary

Manhole # S21SS1011MH

Insp Date: **12/4/06 2:04 PM**

**Location** Address: **HAMILL RD**

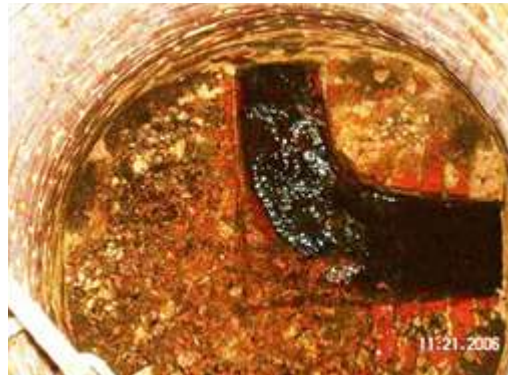
Top View

Evidence of surcharge - Bench debris.

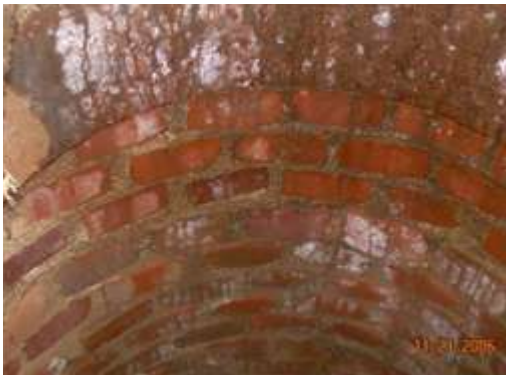
Defect

☒ **Leaks**

Infiltration: ☐ None ☒ **Joint** ☐ Cracks ☒ **Mortar** ☐ Roots ☐ Wall

Infiltration: ☐ None ☐ Joint ☐ Cracks ☒ **Mortar** ☐ Roots ☒ **Wall**

Frame leaks. Adjustment and Corbel infiltration.

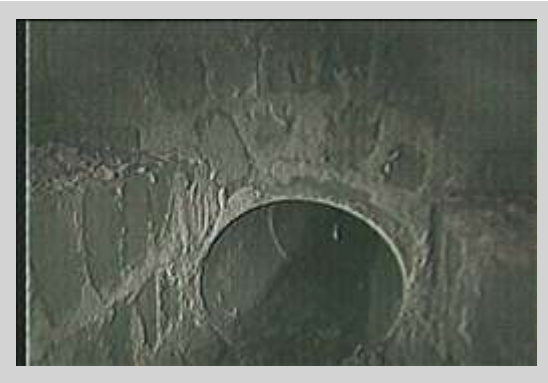
### 10 in. Circular Gravity Sewer Pipe Out @ 12 O'Clock

Infiltration: **Evidence** Pipe Seal Cond: **Cracked**

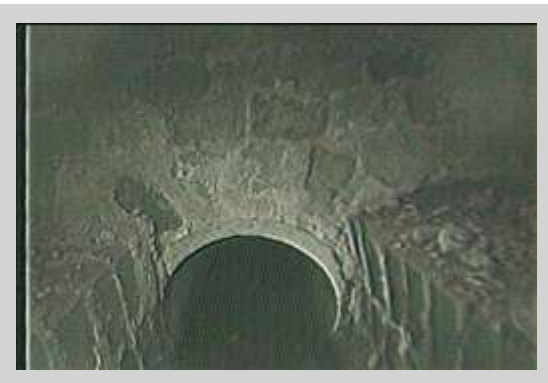
### 10 in. Circular Gravity Sewer Pipe In @ 3 O'Clock

Infiltration: **None** Pipe Seal Cond: **Unknown**
